## User's Guide for PARALLEL<sup>®</sup> Log Saw Blades

<b>1. INITIAL REMARKS: IN BRIEF BUT IMPORTANT</b>	<b>3</b>
1.1 Introduction	3
1.2 Definition of Terms Used in this Manual	4
1.3 Standard Dimensions of Log Saw Blades*	5
1.4 Safety Instructions	7
<b>2. HANDLING OF LOG SAW BLADES</b>	<b>7</b>
2.1 Storage	7
2.2 Transportation	8
2.3 Assembly/Disassembly	9
2.4 Initial Sharpening for Commissioning of a New Log Saw Blade	10
2.5 Sharpening the Log Saw Blade During Use.	10
2.6 What to Do With Worn Blades	11
<b>3. TROUBLE SHOOTING GUIDE</b>	<b>12</b>
3.1 For Your Fast Understanding	12
3.2 Quality of Paper and Core Stock	15
3.3 Grinding System, Faults During Grinding/Sharpening	15
3.4 Condition of Machine (Shaft, Hub, Speeds, Cutting Depth)	19
3.5 Quality of the Log Saw Blade	22
<b>4. RECOMMENDATIONS FOR FAST TROUBLE SHOOTING</b>	<b>23</b>
<b>5. SUPPORT FROM BLECHER FOR FAST TROUBLE SHOOTING</b>	<b>24</b>

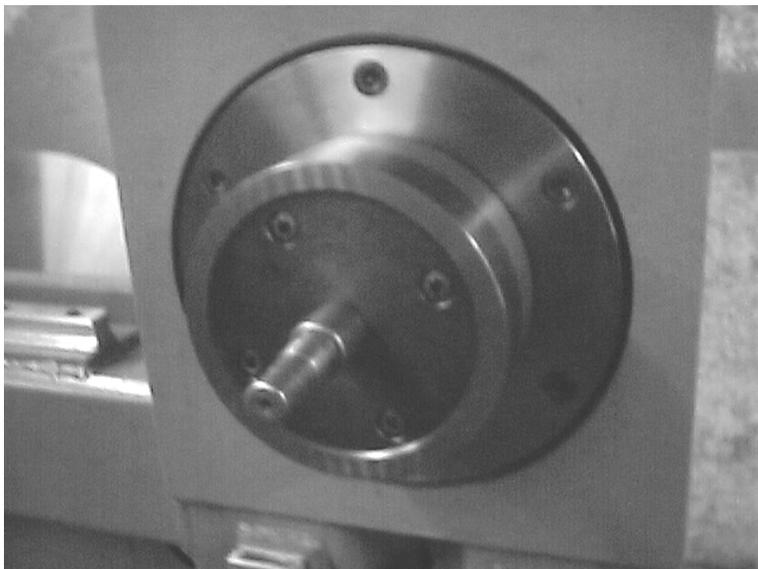
Hub with  
sufficient  
undercut  
between  
centre and  
clamping  
ring

clamps the log saw blade in place) and hub/flange cover centre. The undercut will be sufficient if the clearance between centre of hub and centre of flange cover is between 1,0 – 1,5 mm. If it falls below that value (e.g. because of reworking the hub and flange cover) the clamping surface is no longer defined and may go beyond the clamping ring - this inevitably will increase lateral run-out of the log saw blade installed to such a hub.
